1 Impact of drainage problems on cranberry yields: Two case studies

8 The impact of two drainage problems on cranberry yield was investigated. In the first case, a
9 yield decline of 39% was measured for cranberries growing over clogged drains and, in the
10 second case, an inadequate design of the drainage outlet was associated with a 25% yield
11 reduction. This yield decrease vanished the following year after redesigning the outlet.

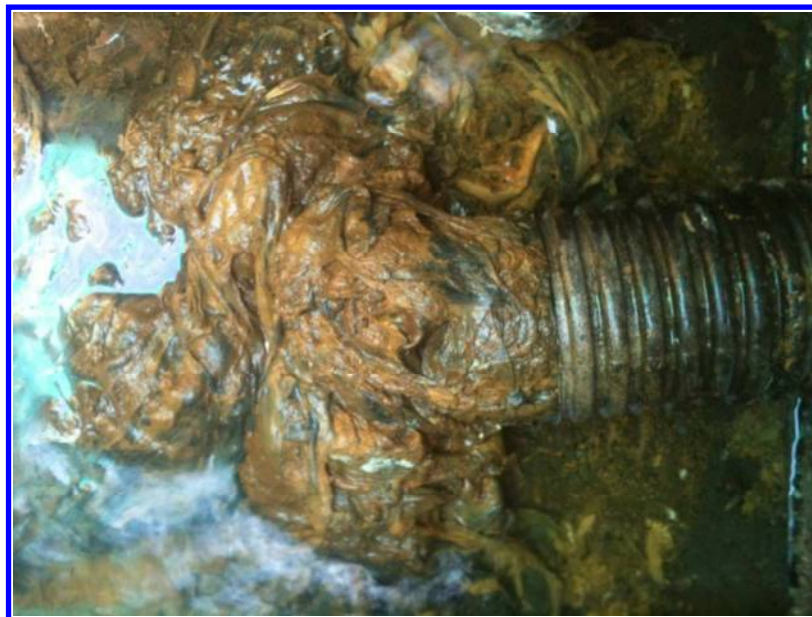
160 **Fig. 1.** The swollen masses found at the drain outlet after pumping water at low operating
161 pressure (300 kPa) in drain pipes for washing.

43 clogged in that section. On June 7, chimneys were connected to drain pipes in the middle of the
44 bed and a cleaning system used for removing the clogging material. The cleaning system
45 consisted of a 2.5-cm diameter flexible hose inserted into the chimney, connected to a 3.75 kW
46 gasoline pump operated at 300 kPa and delivering $35 \text{ m}^3 \text{ h}^{-1}$ of water. The water leaving the drain
47 outlet was black and contained clumps of clogging material. These swollen masses smelt bad,
48 were gelatinous and some masses were white to yellow with tan tinges while some were red to
49 tan with black tinges (Fig. 1). After cleaning, red to tan deposits were found in some of the drain
50 perforations, but not at the outer surface of the synthetic drain envelope. The red vines slowly
51 turned to green three weeks after cleaning, but some died (Fig. 2). Before cleaning the drains, the
52 soil solution was sampled ($n=3$) for Mn and Fe^{2+} analysed with the color disk method (model

63 Analyses of the soil solution did not detect Mn, but resulted in Fe^{2+} concentration of more than
64 5.0 ppm , i.e. the maximum value detectable by the color disk. According to Ford (1982), Fe^{2+}
65 levels above 2.5 ppm are problematic for drainage systems and often present severe ochre
66 problems. A concentration of 24% of organic matter (dry wt.) was found in the swollen masses,
67 much higher than the $\sim 1\%$ typically found in sandy beds. Similar concentrations ($\sim 20\%$) were

68 found in ochre deposits in Scotland (Wheatley, 1988). Although the sulfur concentration was not
69 measured, the color, the smell, the presence of organic matter and iron, all pointed to the swollen
70 masses being composed of iron ochre mixed with sulfur slime (Ford, 1993).

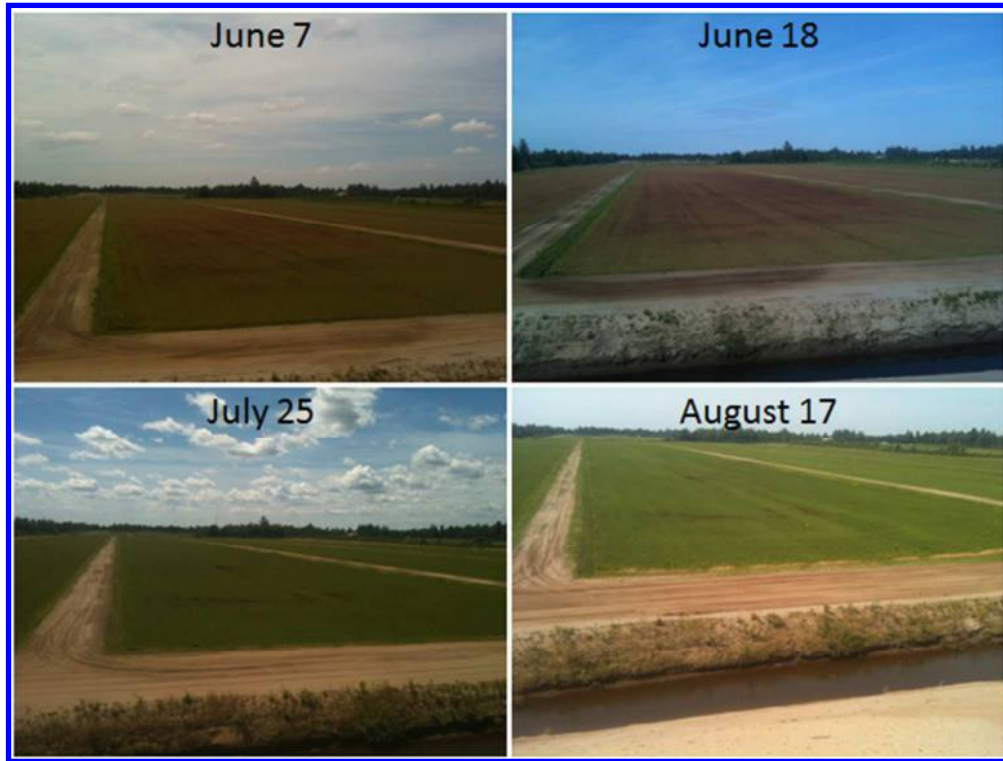
163 **Fig. 2.** Monitoring the development of cranberries growing over drain pipes clogged with swollen
164 masses from June 7 to August 17 2012. Drain pipes were washed on June 7.

58 Cranberries growing over the clogged drain pipes yielded a significant yield loss of 39% ($p <$
59 0.001) relative to cranberries growing over properly functioning drain pipes. Indeed, the yield
60 was 21951 kg ha^{-1} in the poorly drained section and 36135 kg ha^{-1} in the well drained section.
61 Although it was not measured, the yield reduction in the poorly drained section most likely
62 persisted in the subsequent years, because of plant death.
